## Home Inspection Report For:

1234 Any Street  
Anytown, USA 12345

Inspector: Matthew Bartels  
NCHILB License # 2490  
Report Number: XXXXXX  
Date of Inspection: XXXXXX

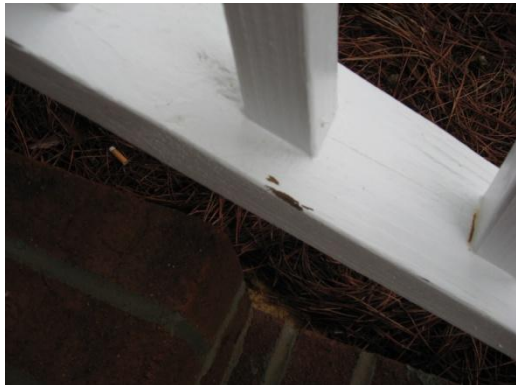
### 2.3 Steps/Stoops/Porch

**Comments:** Chipped paint was found at the front porch steps railing. Re-paint as needed.

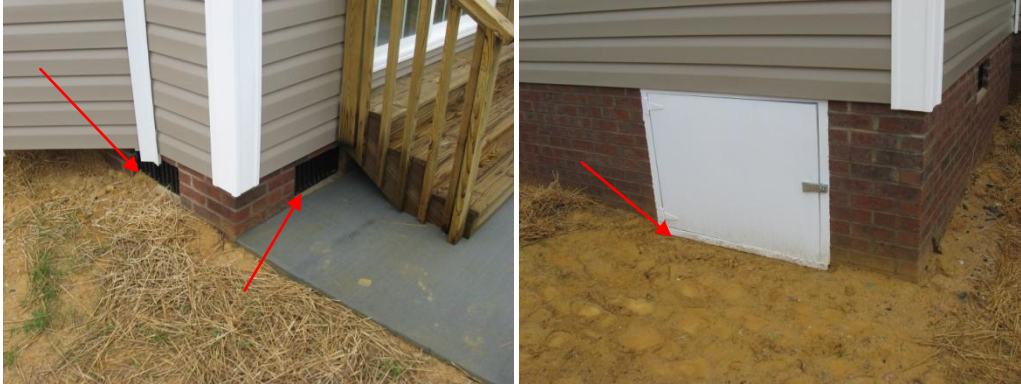
## 2.6 Landscaping Affecting Foundation

**Comments:** The concrete patio at the rear of the house is poured up to the bottom of the foundation wall vents. See Landscaping Affecting Foundation for more information. Section 2.6

**Comments:** The grade at the left side of the house (near crawl space door) and at the rear, right corner and patio area is too high. The soil and concrete levels at the right, rear corner and patio are up to bottom of the foundation wall vents. Fresh water stains were visible under these vents from the crawlspace. Window wells should be installed when grade is less than 3 inches to the bottom of a foundation vent. The grade at the left side of the house, at crawlspace door, is all the way up to the bottom of the crawlspace door. This will allow water to enter into the crawlspace from under the door sill and make opening the door difficult, if not impossible, when grass or other vegetation is planted. Grading should be altered (lowered) as needed and/or window wells should be installed around foundation vents as needed to prevent water from entering the crawlspace.

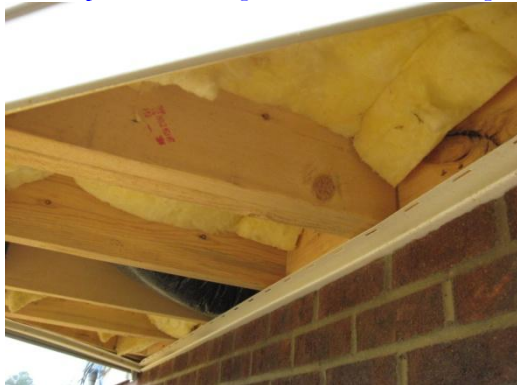
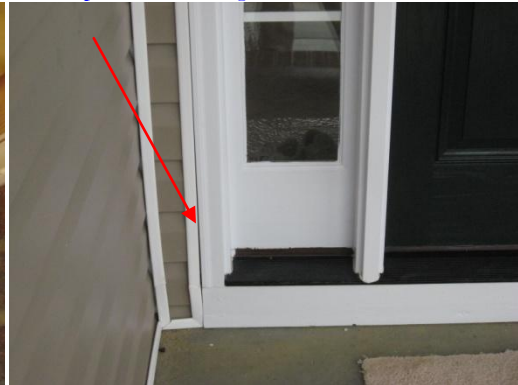
### 4.3 Siding

**Comments:** Caulking is needed around the phone and cable lines where they pass through the exterior wall.

Caulking is needed between the J-channel and front door trim.

A soffit panel is missing from under the dining area bump out on the right side. (Insulate first!)

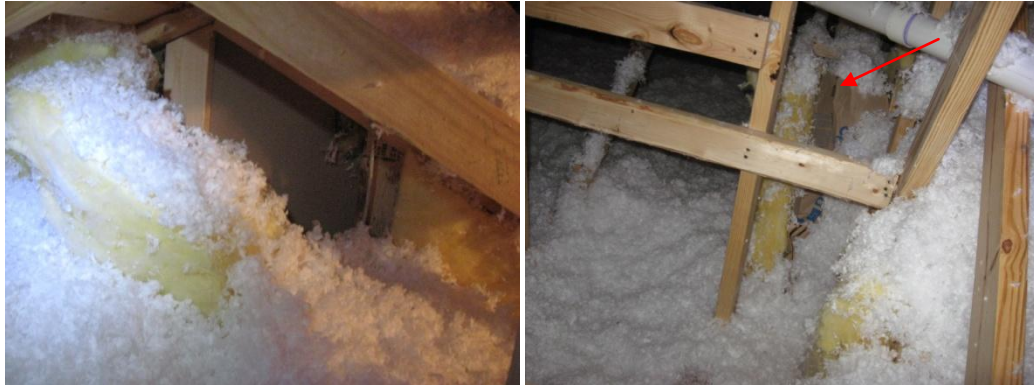
Material: Fiberglass  
Type: Batts Loose fill  
Average Inches: 10-12  
Vapor barrier: Kraft Paper  
Concerns:  Voids/Missing insulation  Vapor barrier installed on wrong side  
 Insulation appears inadequate  Two or more layers of vapor barrier  
Comments: [Insulation was not secured and falling from the drywall at the front, center bedroom cathedral ceiling, and at the master bedroom cathedral ceiling. Re-install and secure insulation as needed.](#)

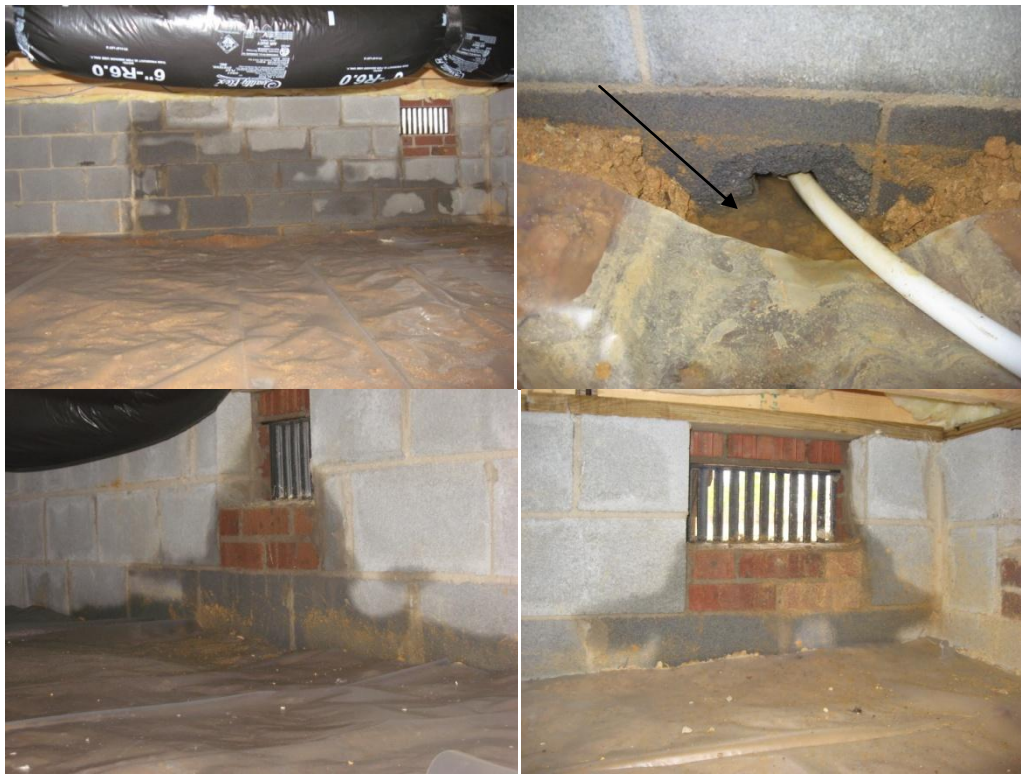
Comments: Fresh water stains were found on the foundation walls at the rear foundation wall vents and at the front wall, opposite side of the front steps. Standing water was found around the water service entrance pipe at the front wall. Measures to eliminate the water from the crawl space may include re-grading, installing window wells at foundation vents, the installation of gutters and downspouts, and sealing around the utility entrances. Additional steps, such as excavation and the installation of a perimeter drainage system, damp proofing; etc may be needed if problem persists. Crawlspace water penetration should further investigated and be addressed by a contractor familiar with water and moisture management.

The vapor barrier has been wrinkled and moved, creating large voids in its coverage. Redistribute vapor barrier to cover the entire crawl space floor.

**Comments:** Fresh water stains were found on the foundation walls at the rear foundation wall vents and at the front wall, opposite side of the front steps. Standing water was found around the water service entrance pipe at the front wall. Measures to eliminate the water from the crawl space may include re-grading, installing window wells at foundation vents, the installation of gutters and downspouts, and sealing around the utility entrances. Additional steps, such as excavation and the installation of a perimeter drainage system, damp proofing; etc may be needed if problem persists. Crawlspace water penetration should further investigated and be addressed by a contractor familiar with water and moisture management.  
The vapor barrier has been wrinkled and moved, creating large voids in its coverage. Redistribute vapor barrier to cover the entire crawl space floor.

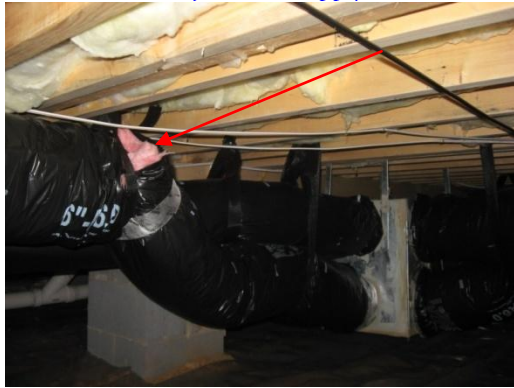
Comments: A joint in a supply air duct in the crawlspace has come loose. Repair/Replace

**Comments:** A joint in a supply air duct in the crawlspace has come loose. Repair/Replace
