Home Inspection Report For:

Inspector: Matthew Bartels
NCHILB License # 2490
Report Number: XXXXXXXX
Date of Inspection: XXXXXXXX

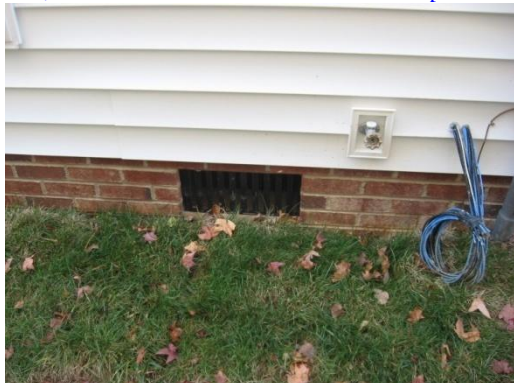
Comments: • Soil levels were very close to the foundation wall vent on the left wall. The soil level should be lowered, keeping in mind the need for positive slope away from the foundation, or a vent/window well should be installed to prevent surface water from entering into the crawlspace.

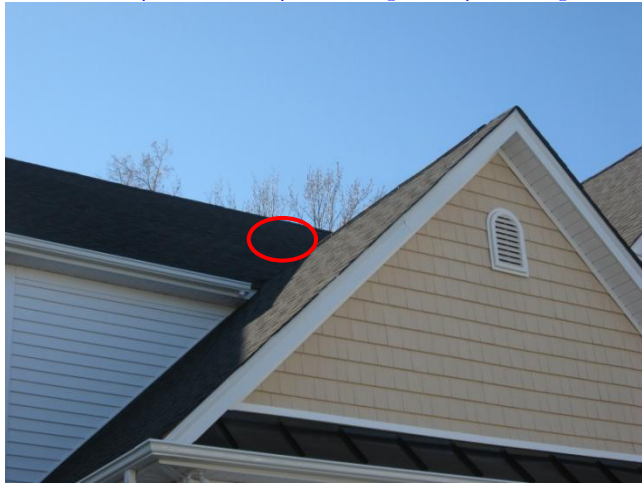
Comments: •“Nail Pops” or shingles not lying flat were found at about the center of the front main gable roof. (See picture) The raised nails leave a path for water entry and greatly increase the chances of the shingles blowing off during heavy winds. These Nail Pops should be repaired as needed.
• Construction debris (nails/shingle cutoffs/etc) was present on the roof. Remove all loose debris as it will eventually make its way into the gutter system of grounds.

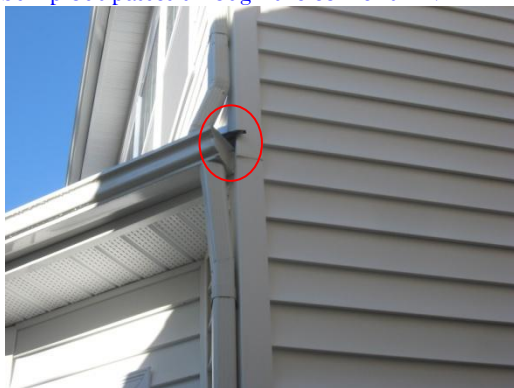
Comments: • Sealant or flashing should be added at the rear, left corner where the roof from the bump out passes through the corner trim.

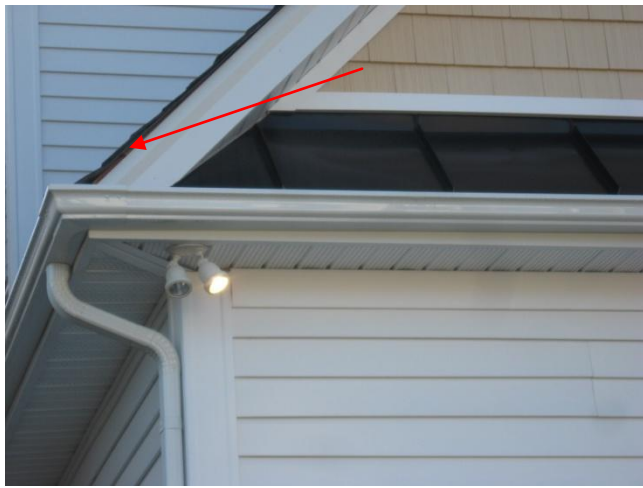
Comments: • Large gaps are present between the top of the fascia cladding and the roof shingles in multiple areas. An additional piece of trim or drip edge should be added to protect the currently exposed OSB roof sheathing from the elements.
• Recommend re-caulking and touch up paint as needed at the right side dining room bump-out.

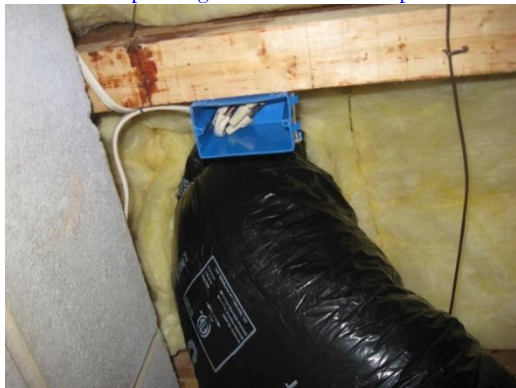
Comments: •A junction box located at the rear, center of the crawl space was missing a cover. Install cover.

- The front, left floodlight is out. Replace bulb or repair as needed.
- The crawspace light was broken. Replace.

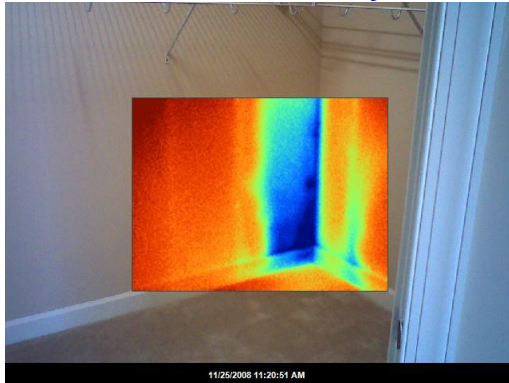
Blue area shows missing insulation in closet

Insulation should be installed or repositioned as needed by a capable insulation contractor.

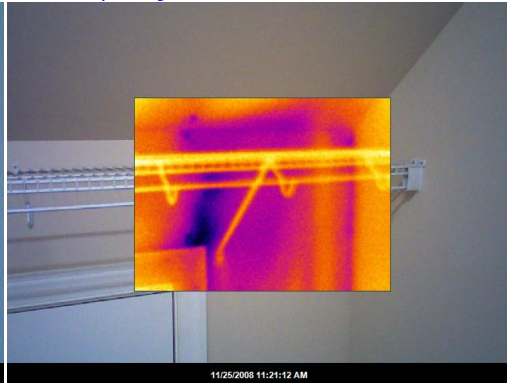
Purple area is inadequate insulation near knee-wall door

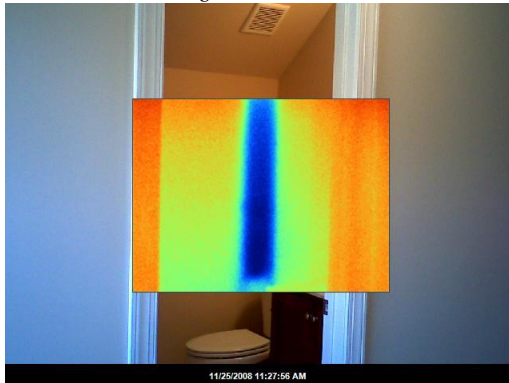
Missing insulation in wall near 3rd floor bathroom toilet

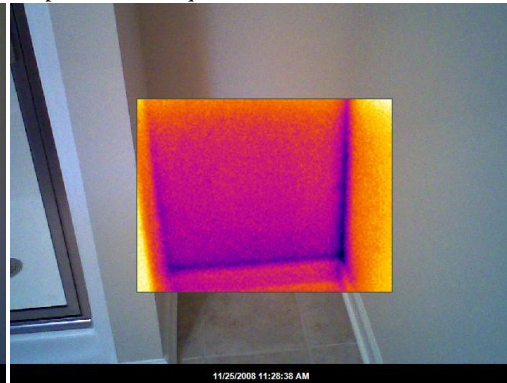
Purple area is inadequate insulation at bathroom alcove

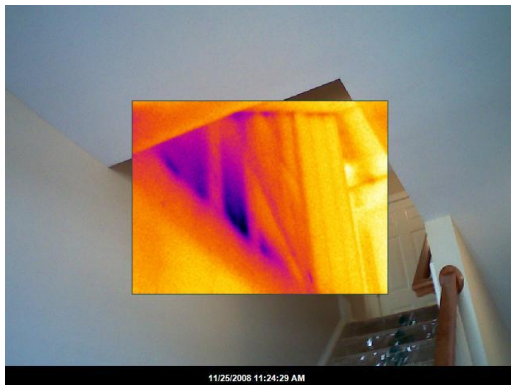
Purple area shows inadequate insulation at 3rd floor stair

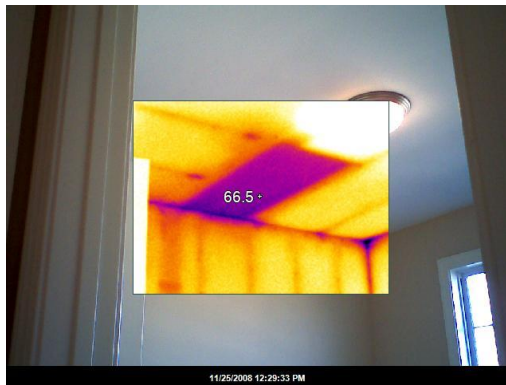
Purple area shows missing insulation in bedroom ceiling

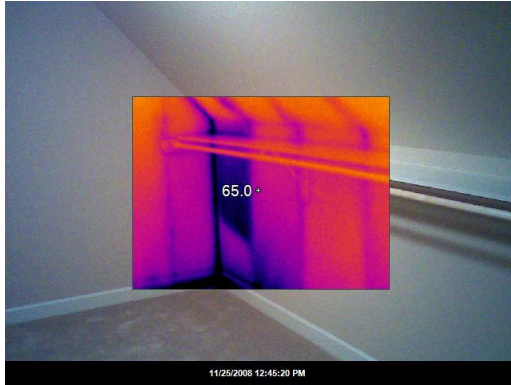
Purple area shows missing or inadequate insulation in master bedroom closet knee-walls.

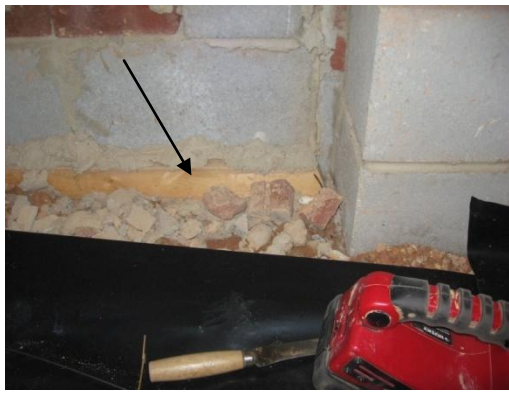
Comments: •A piece of OSB and a 2X4 were stuck in the dirt floor of the crawlspace. The OSB was located at the right wall and the 2X4 was located at the rear center of the crawlspace. All wood scraps should be removed to deter termite infestation.
