Home Inspection Report For:

1234 Any Street
Anytown, USA 12345

Inspector: Matthew Bartels
NCHILB License # 2490
Report Number: XXXXXXXX
Date of Inspection: XXXXXXXX

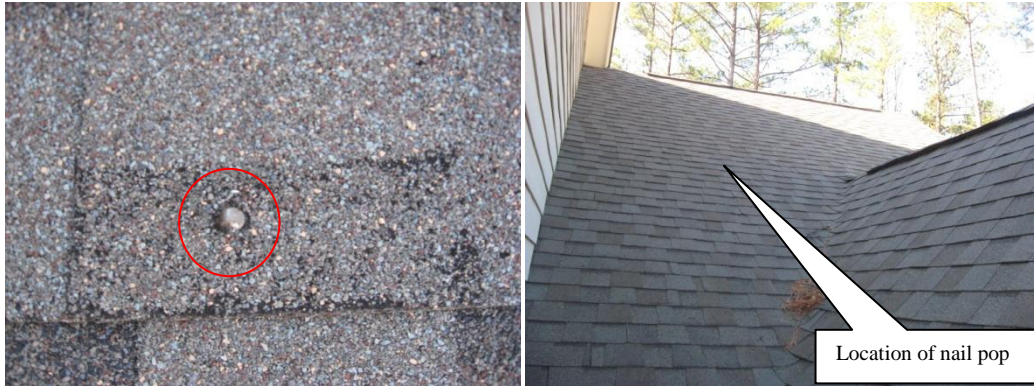
Comments: A nail pop was found at the gable roof in the general area over the laundry room, near where the garage gable roof intersects with the main roof. Repair and reseal as needed.

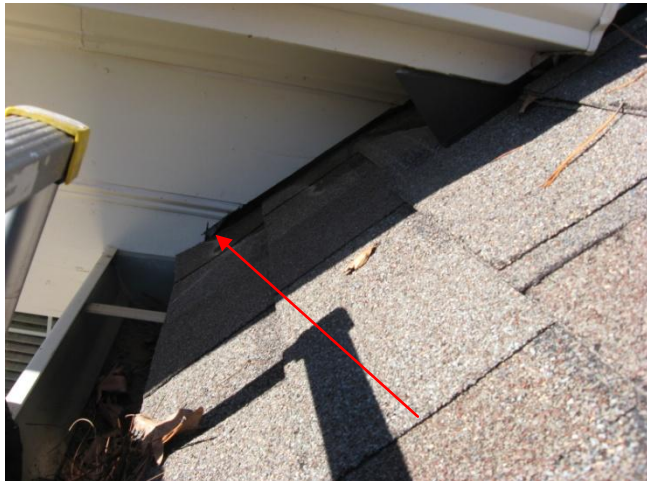
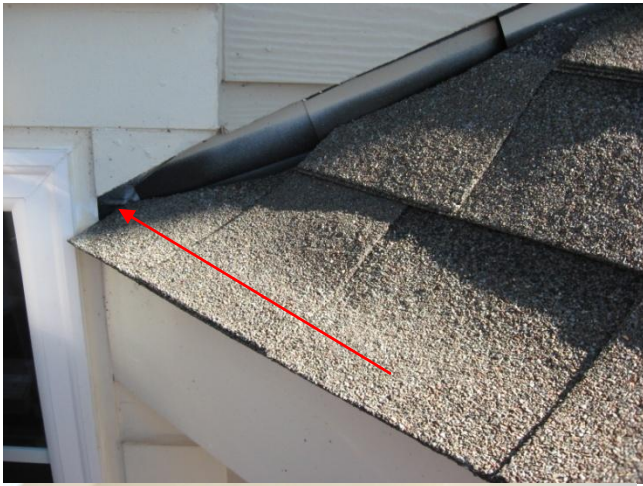
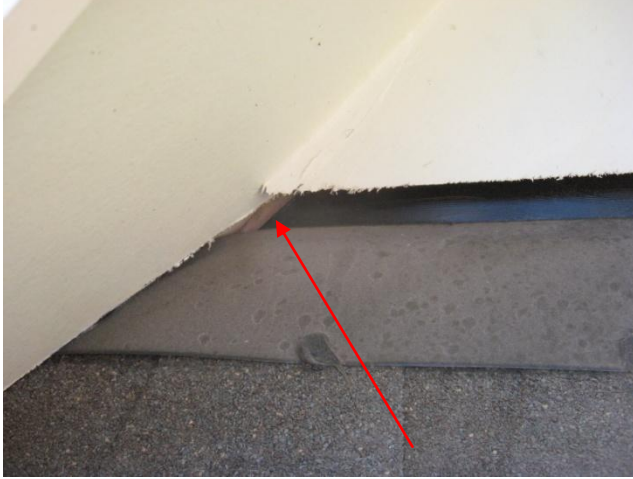
Comments: Many flashings at roof/wall intersections, where rake abuts the main gable roof, at the small section of roofing directly above the garage doors, where the porch roof intersects with the garage gable roof, and at the eat-in-kitchen bump out roofing were missing complete flashings, kickout flashings, and/or sealant. These missing/incomplete flashings leave these spots vulnerable to water penetration from blowing wind and rain. A competent roofer should add flashings and/or sealant as needed to these areas as needed.

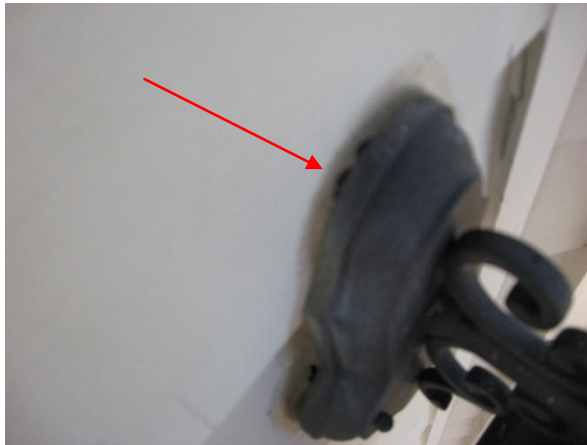
Comments: Re-caulking is needed around the base of the exterior light at the rear deck. Seal as needed.

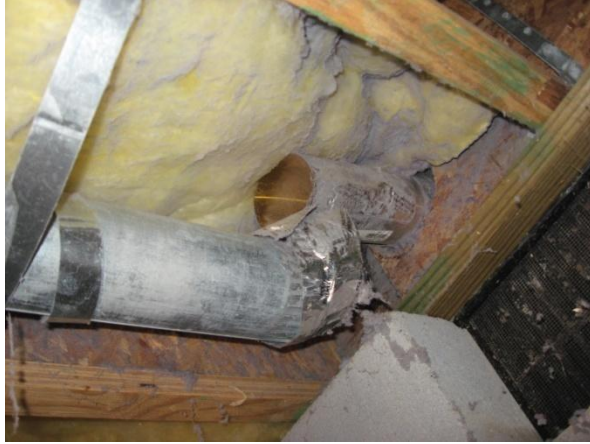
Comments: The dryer vent was disconnected in the crawlspace. Re-attach as needed.
Not operated

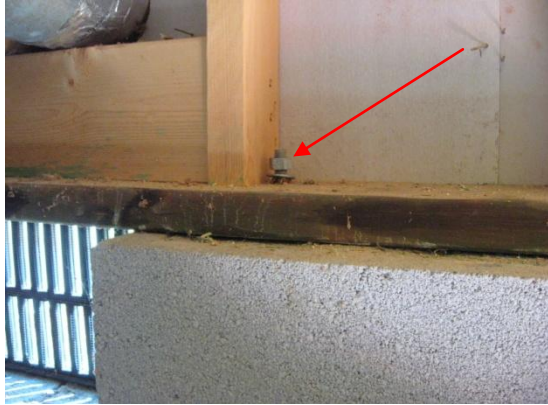
Comments: A bolt at the sill plate, near the crawlspace hatch, is not secured. Repair

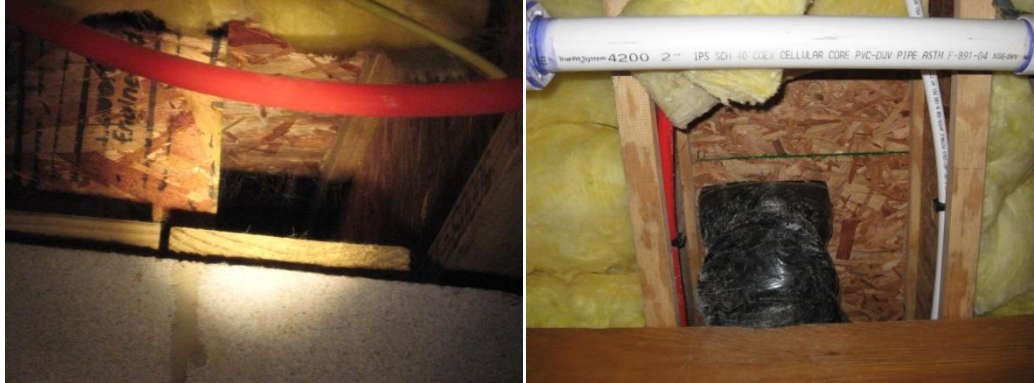
Comments: Insulation was inadequate or missing around many air registers and in areas between the joists along the front of the crawlspace. Insulation should be redistributed and added as needed to all these areas to fill any voids.
